# Risk-Based Management of Mechanical Integrity in Air Products Hydrogen Steam Methane Reformer Plants

Presentation by

**Matthew Akhurst**

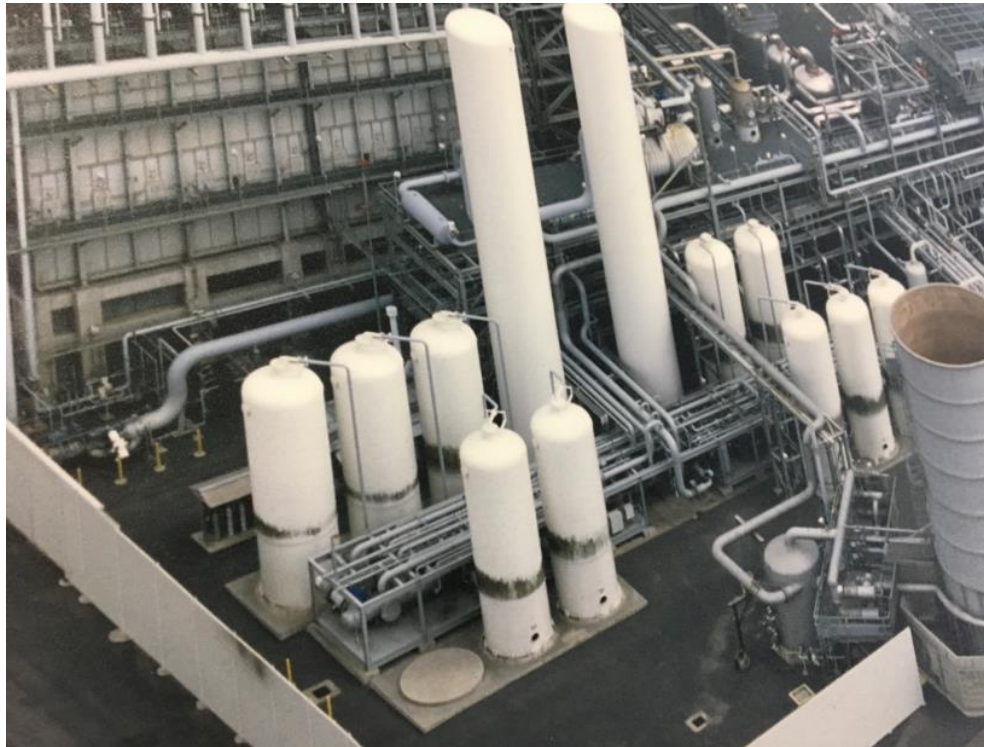
- Pressure Swing Adsorber (PSA) to purify Syngas using an adsorbent bed to remove impurities at process pressure, regenerated at low pressure (~5min cycle).
- Multiple vessels are required due to the adsorbent's limited capacity, requiring periodic regeneration

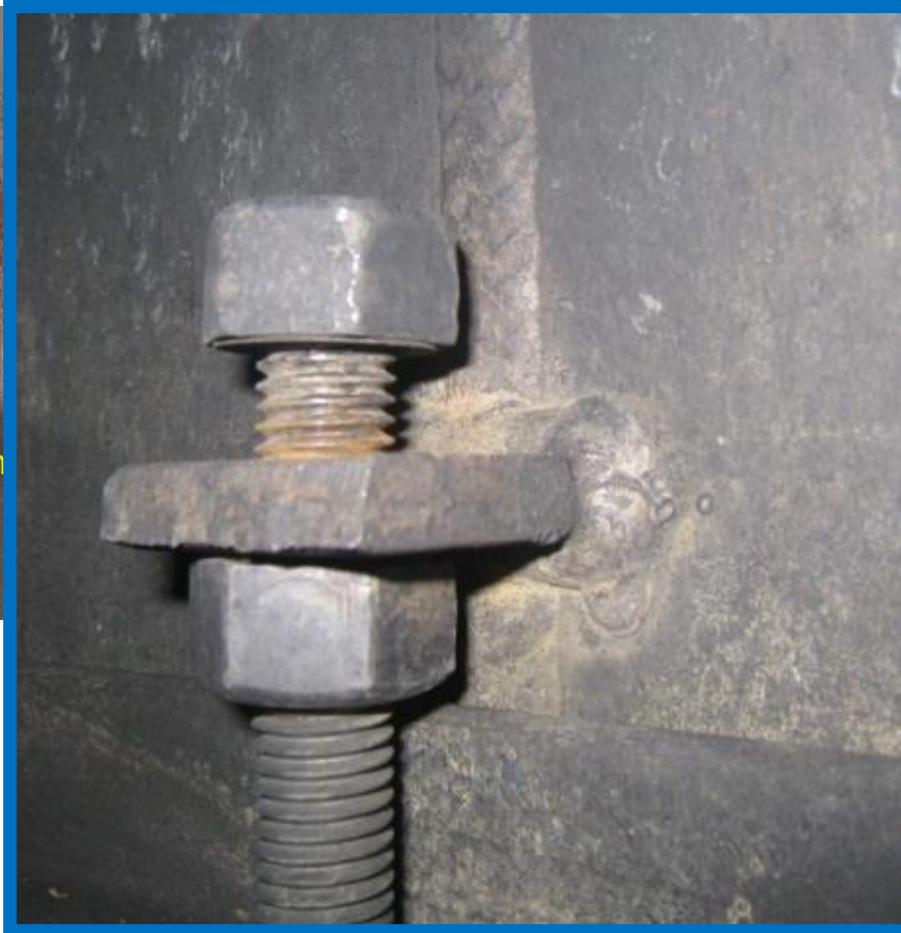
## Design & Fabrication

- Attachment welds create local stress that when placed near longitudinal seams increase potential for fatigue damage

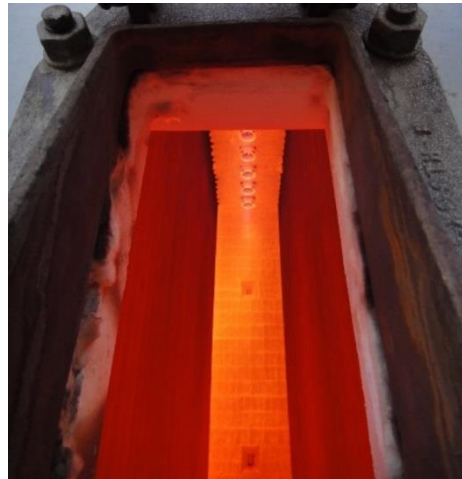
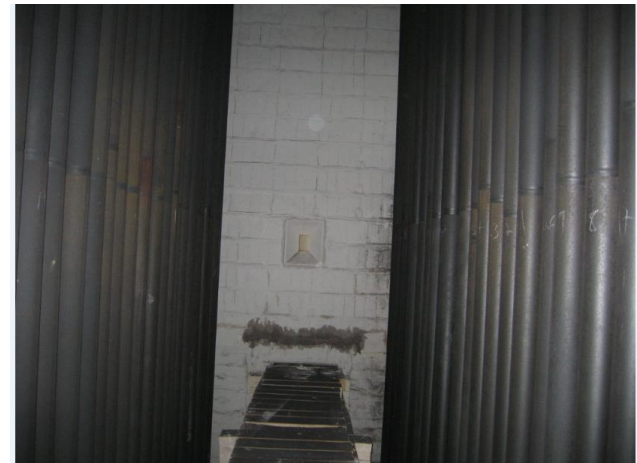
- Typical large reformers contain hundreds of tubes
- Tubes designed to API 530 "Calculation of Heater-tube Thickness in Petroleum Refineries"
- Tubes are centrifugally cast and typically made out of HK40, HP50, or HP MicroAlloy

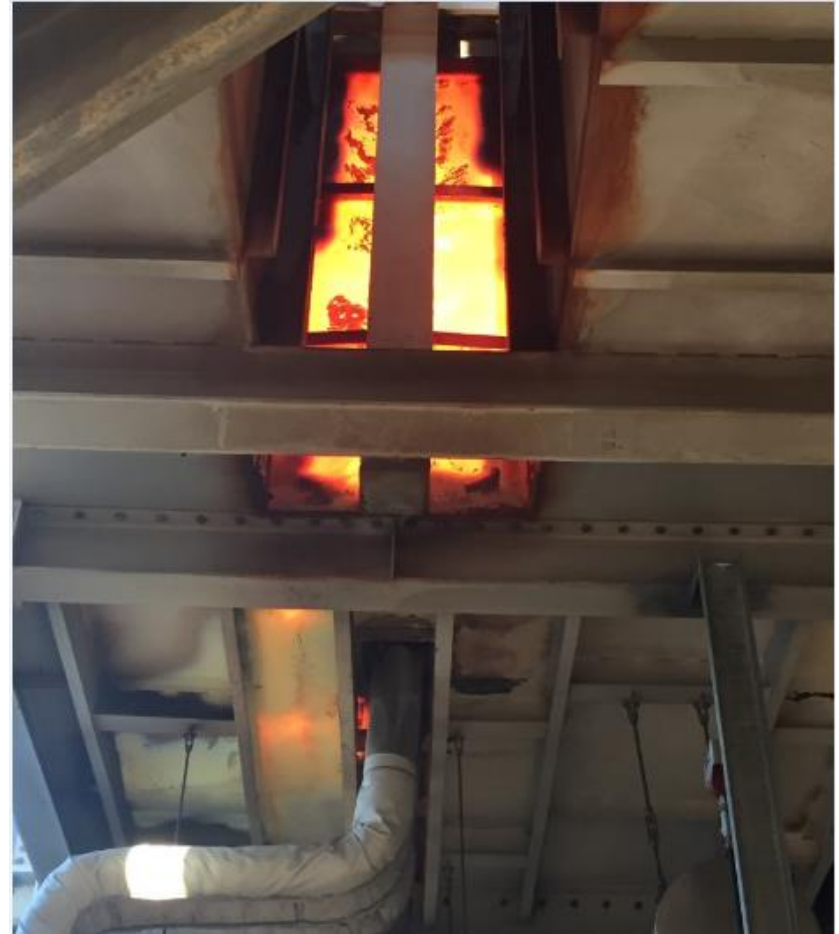
- Primary Failure mechanisms are short term overheat damage, structural deformation, long term creep damage
- Short term overheat from flame impingement and catalyst issues
- Structural deformation (tube bowing) from improper support and uneven heating
- Long term creep from service
  - Tube temperature has large impact on creep life

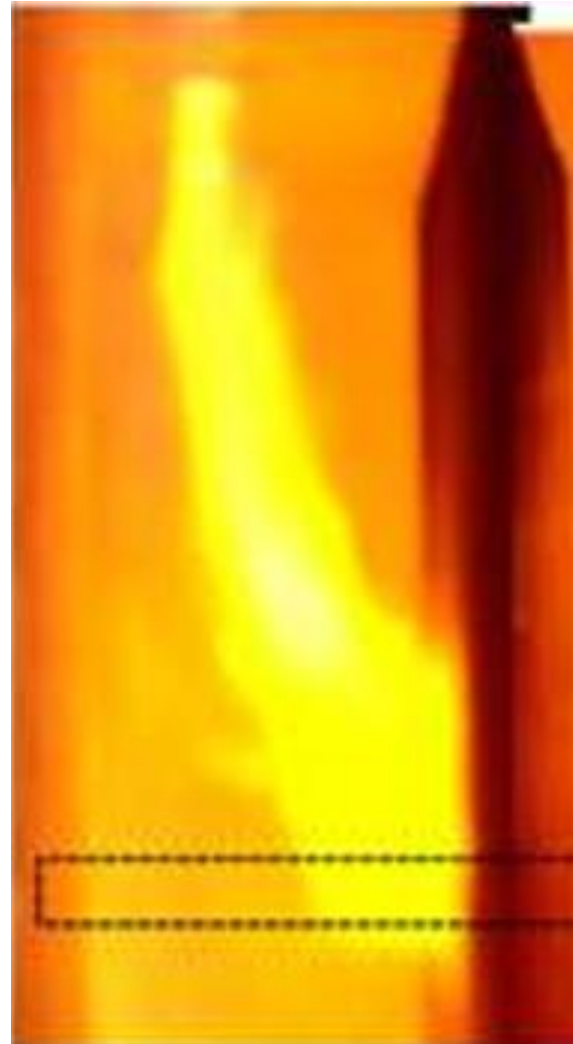
## Short Term Overheat

- Flame impingement

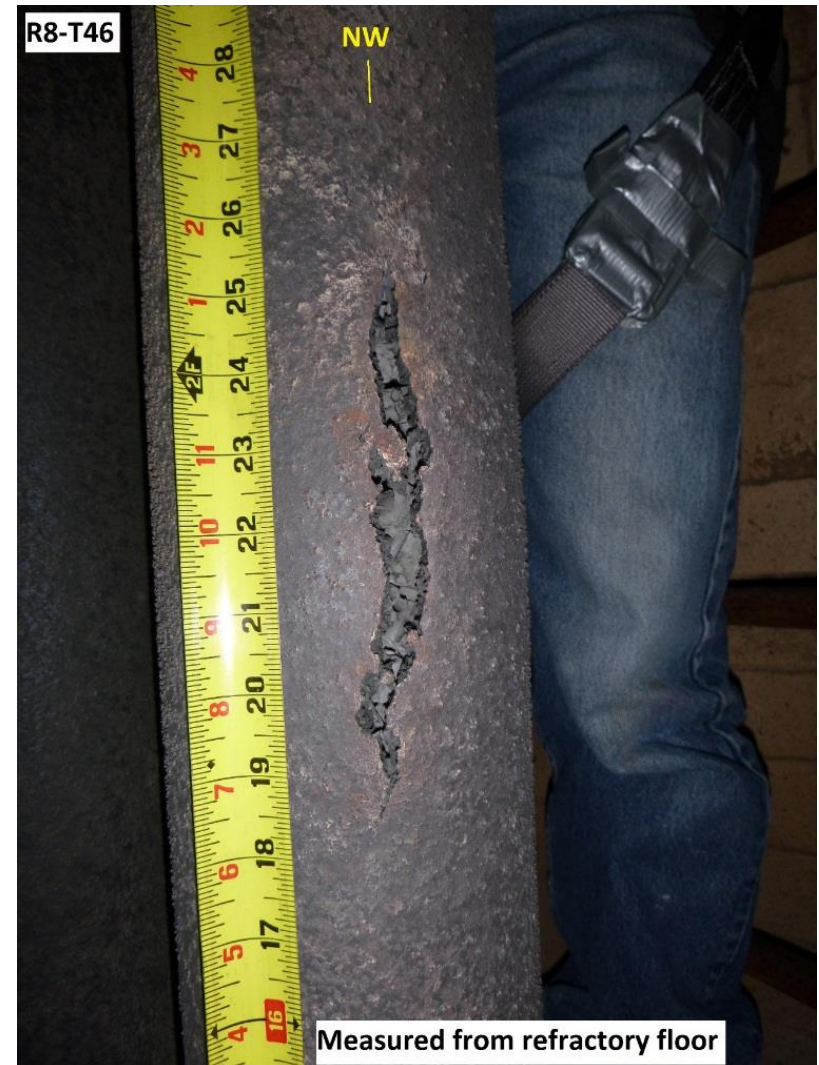
## Long Term Creep

- Long Term Creep Damage occurs at the consistently hottest part of the tube, typically near the floor on a top fired, down flow furnace
- Creep fissures develop mid-wall and propagate to failure

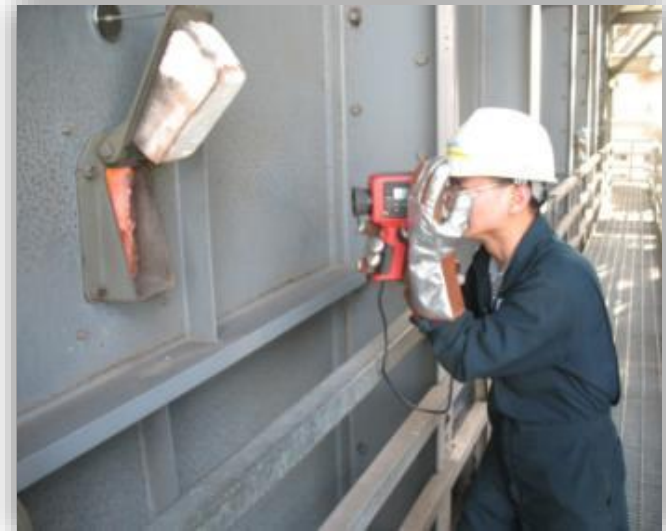
- Visual inspection during operation
- Tightly balanced tube temperatures keep tubes within IOW
- Periodic tube temperature measurement via pyrometer
  - Correction factors must be applied to account for reflected energy error
    - Under-correction results in economic penalty
    - Over-correction can result in tube overheat & reduced tube life

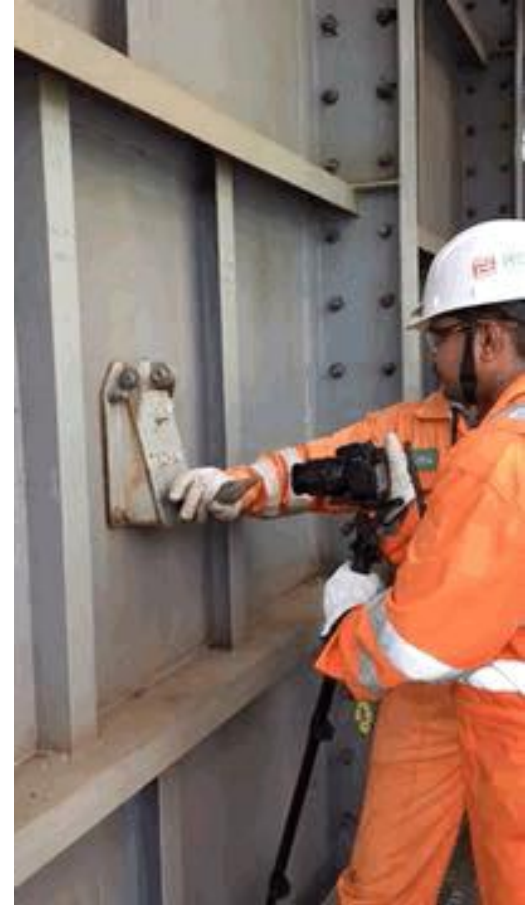
- Tube temperature measurement/balancing using AP Proprietary digital imaging and modelling.
- Periodic tube temperature measurement via OmniCam™
  - OmniCam™ is an Air Products developed technology to measure tube temperature. Identifies hot tubes in locations not visible using standard technology.

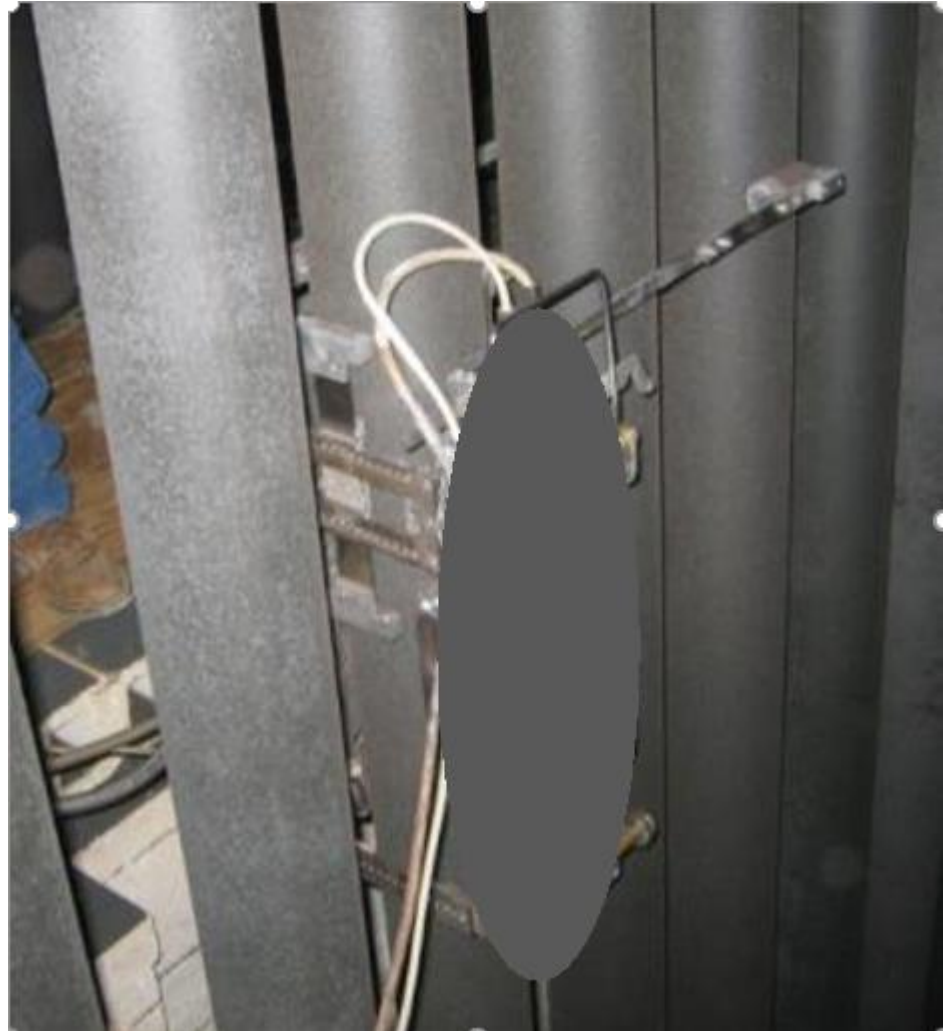
## Off-Line Inspection

- Reformer tube inspection via robotic crawler for creep damage
  - Crack formation
  - Diametrical growth
  - Tube Bowing
- Remaining tube life via destructive testing

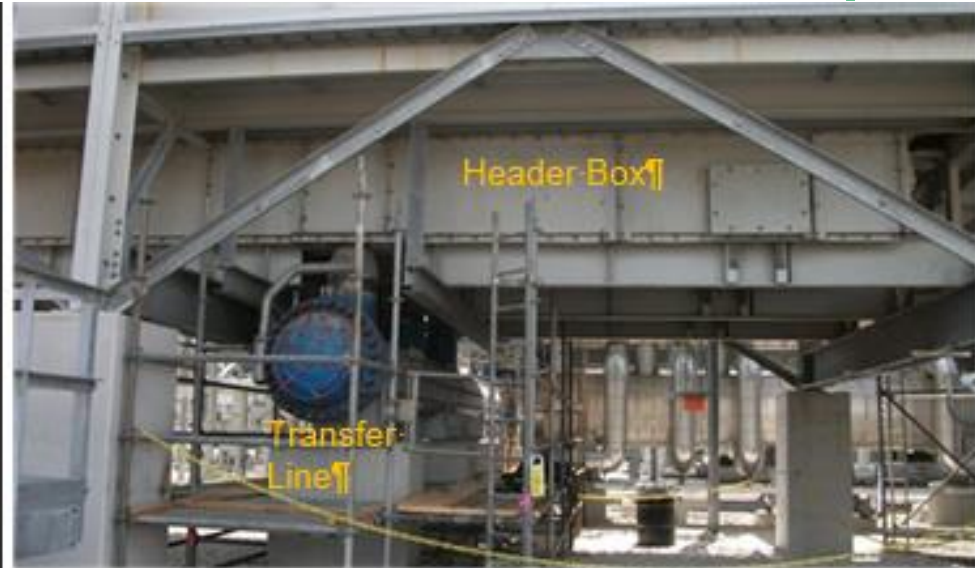
- Comprised cast High Nickel Alloy headers, Inco 800HT wrought pigtails, and low alloy refractory lined piping that conveys ~30 barg, 870 C Syngas to downstream unit operations
- Typically designed with Short or Long Pigtail Design

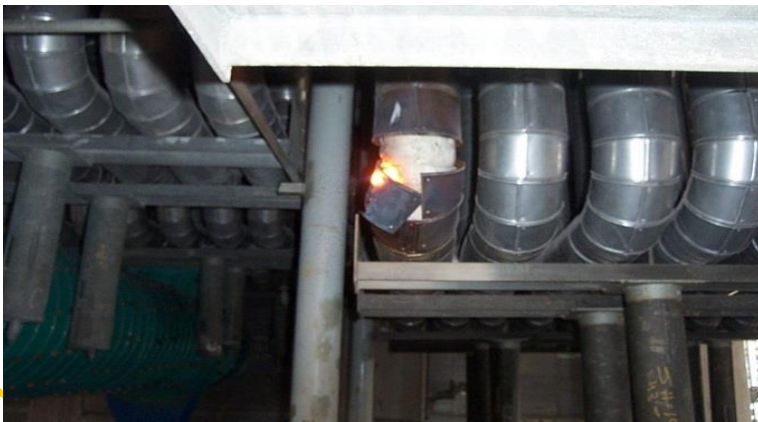
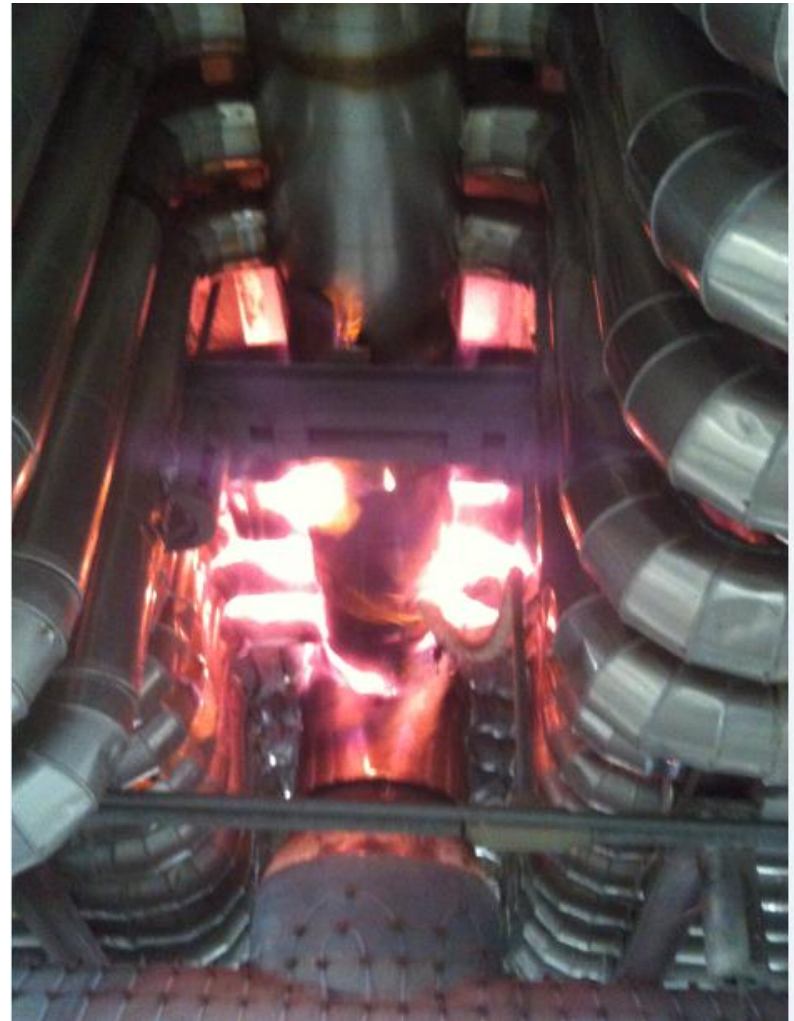
- Primary damage mechanisms are:
  - Short term stress overload from improper support or refractory failure
  - Long term creep damage.
  - HTHA possible if internal refractory lining degrades, allowing metal temperature to enter HTHA risk zone.

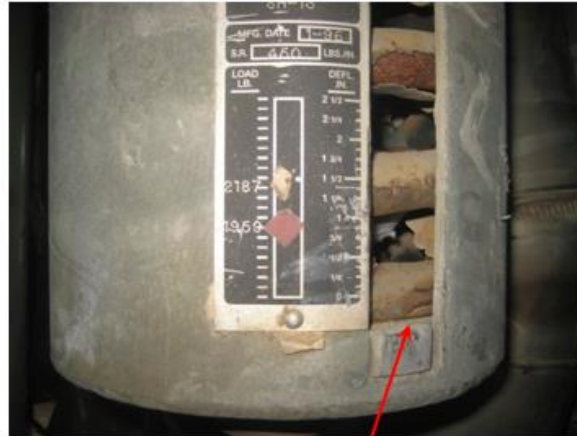
- Visual inspection of spring hangers, supports, and outlet system

Spring Hanger  
bottomed out (no load)

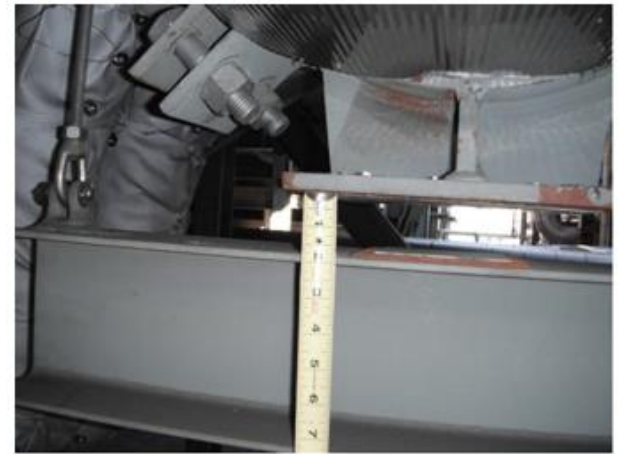
Gap at Support

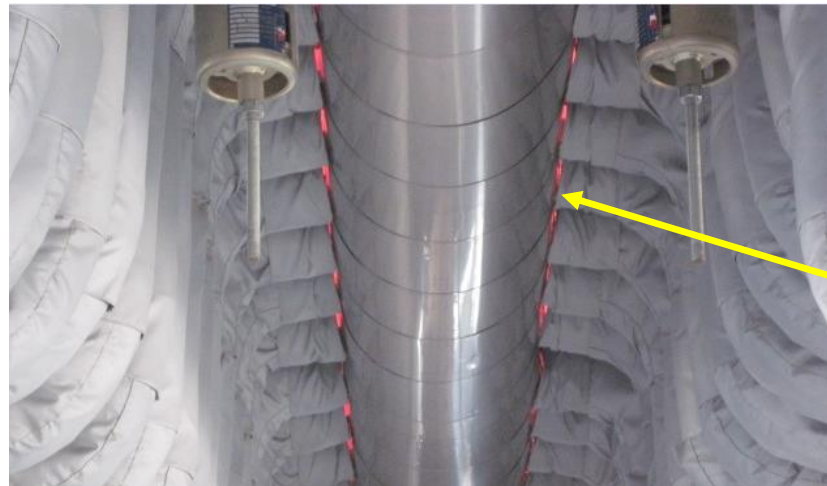
- Visual inspection for damaged insulation that can cause high thermal stress

Insulation gap  
creates  
thermal stress

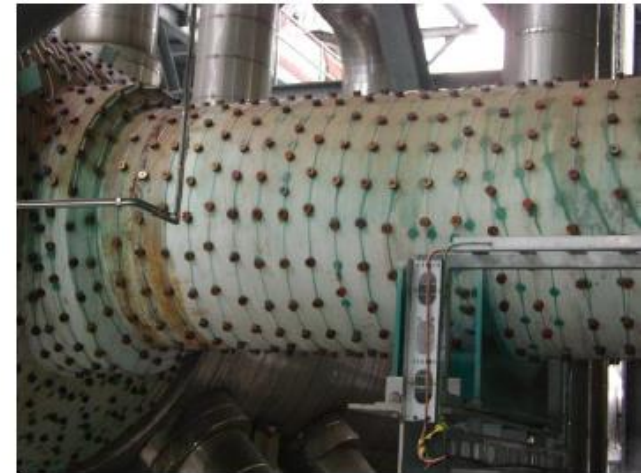
- IR Thermography of Refractory Line Equipment

- On-line inspection is comprised of visual inspection and infra-red thermography
- Off-line inspection is comprised of creep inspections and visual inspection of refractory lined components
- Industry Guidance Documents
  - CGA H-12 "Mechanical Integrity of Syngas Outlet Systems"
  - API 571 "Damage Mechanisms Affecting Fixed Equipment in the Refining Industry"
  - API 573 "Inspection of Fired Boilers and Heaters"
  - API 941 "Steels for Hydrogen Service at Elevated Temperatures and Pressures in Petroleum Refineries and Petrochemical Plants"

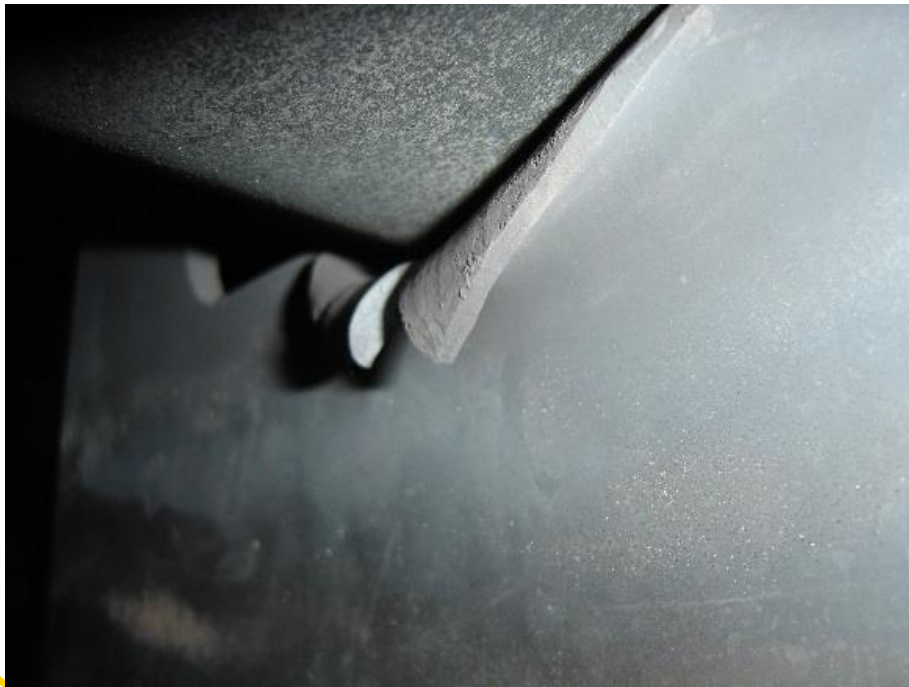
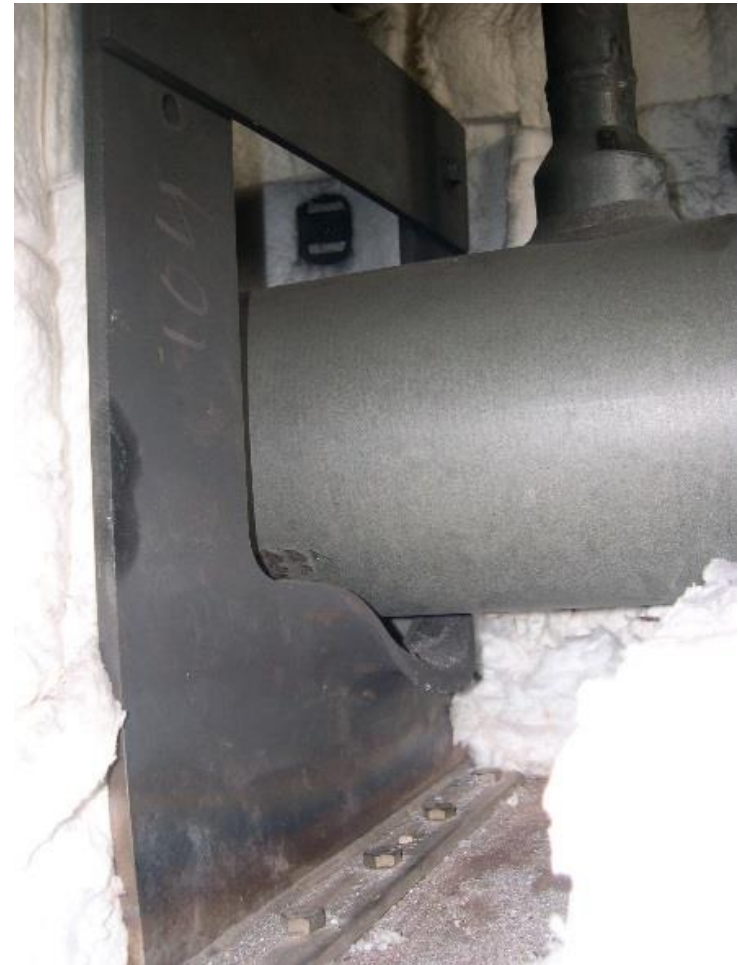
- Invasive visual inspections of supports

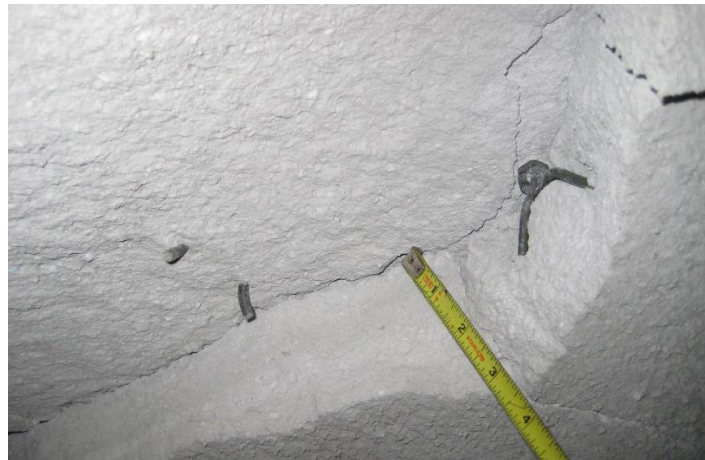
- Internal Visual Inspection of Refractory Lined Equipment

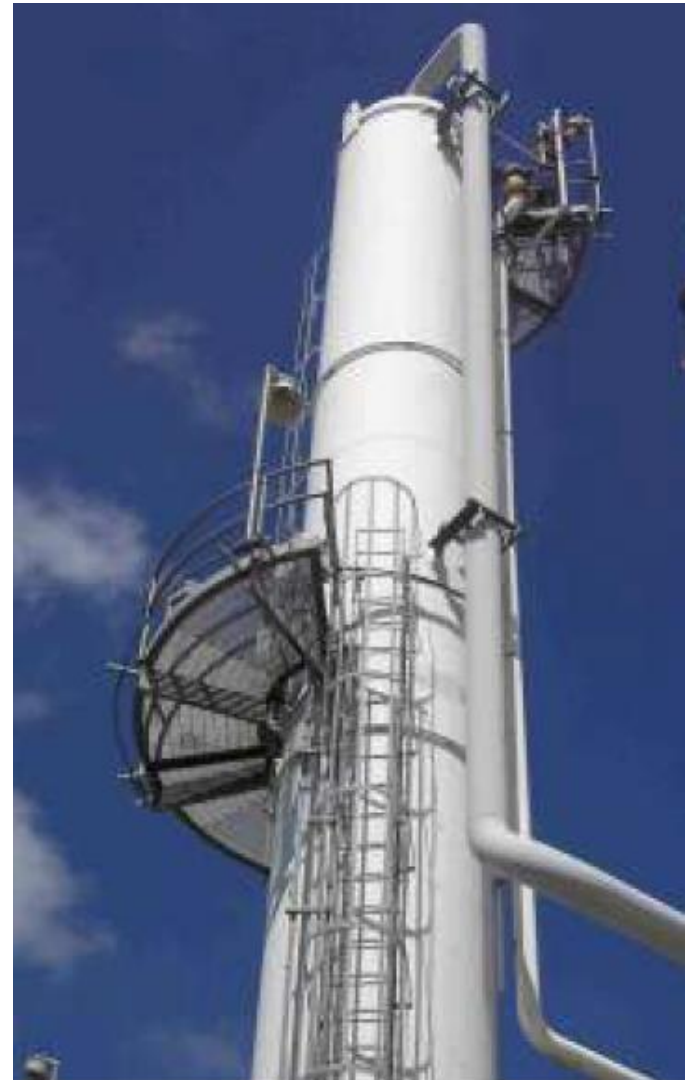
- CO<sub>2</sub> removal service using amine technology
- 20 m tall, CS PWHT Column operates at ~ 40 barg and ambient temperature in Syngas service
- Primary damage mechanism is internal corrosion, which is managed through the use of corrosion inhibitors

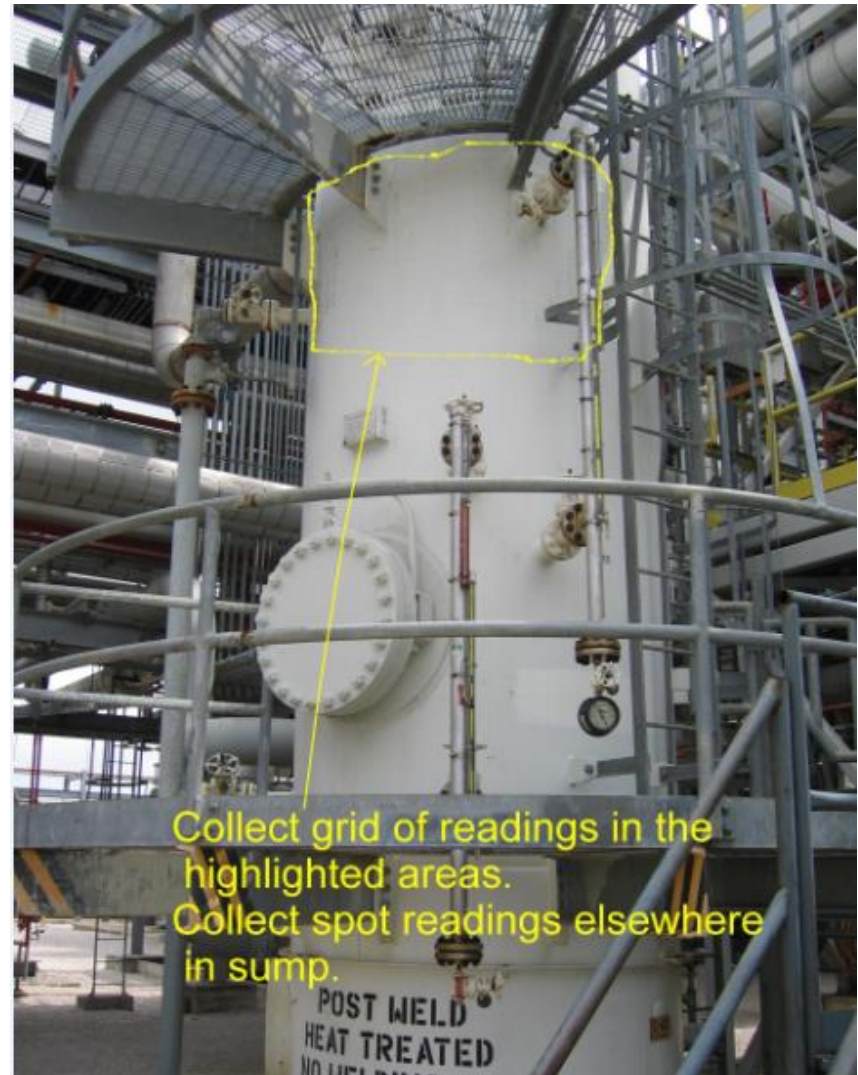
- Response to IOW shift was to restore inhibitor levels and alert Inspection group
  - Corrosion monitoring accelerated
- Condition monitoring showed restoration of inhibitor levels, but continued elevated iron levels.
  - Column passivation required, but outage window not available
  - Corrosion Monitoring strategy modified to ensure safe operation

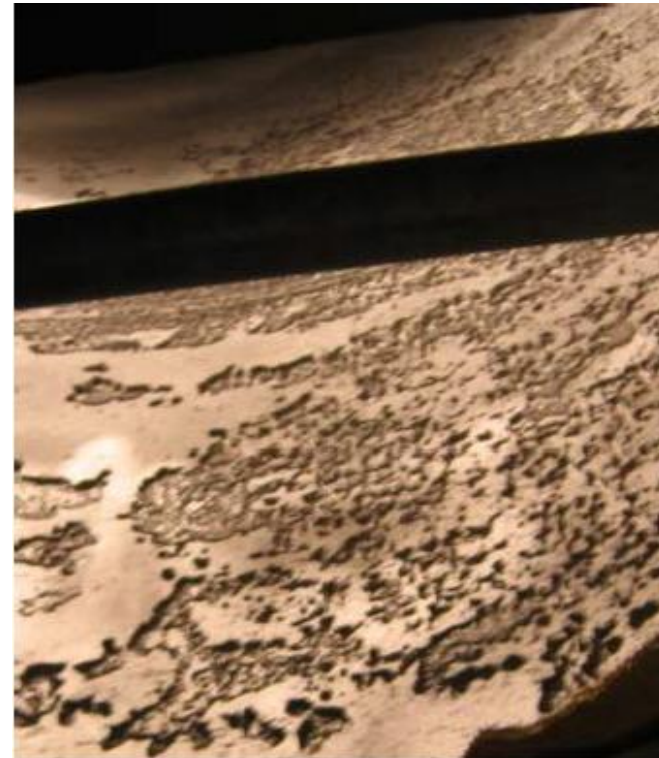
- Corrosion monitoring adjusted to focus on bottom column in areas impacted by inlet distributor
  - Impingement created accelerated corrosion rates
  - API 579 FFS was employed to continue operation of the column until a repair window was available

Elev	1'	2'	3'	4'	5'	6'	7'	8'	9'	10'	11'	12'	13'	14'	15'	16'	17'	18'
Design	1.375	1.375	1.375	1.375	1.375	1.375	1.375	1.375	1.375	1.375	1.375	1.375	1.375	1.375	1.375	1.375	1.375	1.375
Tmin	1.231	1.231	1.231	1.231	1.231	1.231	1.231	1.231	1.231	1.231	1.231	1.231	1.231	1.231	1.231	1.231	1.231	1.231
A (13')	1.242	1.237	1.257	1.248	1.267	1.273	1.284	1.288	1.238	1.274	1.241	1.237	1.244	1.247	1.225	1.249	1.258	1.251
B (12')	1.235	1.221	1.247	1.274	1.255	1.244	1.238	1.238	1.289	1.284	1.228	1.231	1.246	1.257	1.266	1.270	1.265	1.247
C (11')	1.289	1.194	1.231	1.246	1.197	1.244	1.231	1.235	1.268	1.162	1.073	1.132	1.231	1.142	1.177	1.178	1.129	1.263
D (10')	1.258	1.166	1.246	1.194	1.252	1.263	1.261	1.211	1.178	1.212	1.192	1.128	1.178	1.052	0.987	0.924	1.137	1.141
E (9')	1.289	1.265	1.273	1.284	1.281	1.271	1.268	1.273	1.231	1.204	1.153	1.129	1.166	1.134	1.152	1.147	1.241	1.273
F (8')	1.294	1.294	1.284	1.272	1.252	1.243	1.266	1.221	1.184	1.199	1.183	1.174	1.183	1.242	1.235	1.245	1.238	1.248

G (7')	1.267	1.268	1.297	1.247	1.268	1.248	1.218	1.246	1.266	1.240	1.232	1.235	1.240	1.244	1.248	1.241	1.246	1.255
H (6')	1.212	1.23	1.244	1.231	1.184	1.238	1.242	1.234	1.240	1.240	1.242	1.220	1.238	1.212	1.223	1.221	1.226	1.232
I (5')	1.255	1.262	1.264	1.253	1.252	1.251	1.251	1.253	1.241	1.242	1.244	1.236	1.205	1.245	1.261	1.251	1.269	1.222
J (4')	1.237	1.234	1.227	1.251	1.192	1.214	1.242	1.238	1.208	1.193	1.248	1.243	1.271	1.249	1.226	1.237	1.241	1.221
K (3')	MOV	1.222	1.248	1.226	1.194	1.245	1.229	1.221	1.209	1.201	1.222	1.245	1.183	1.252	1.240	1.265	1.253	1.202
L (2')	1.351	1.366	1.369	1.376	1.382	1.371	1.379	1.382	1.385	1.385	1.376	1.372	1.386	1.390	1.389	1.377	1.374	1.376
M (1')	1.382	1.376	1.384	1.380	1.375	1.375	1.377	1.375	1.376	1.374	1.377	1.382	1.378	1.380	1.377	1.383	1.385	1.387
